Vehicle Recovery Incident- Serious Near Miss

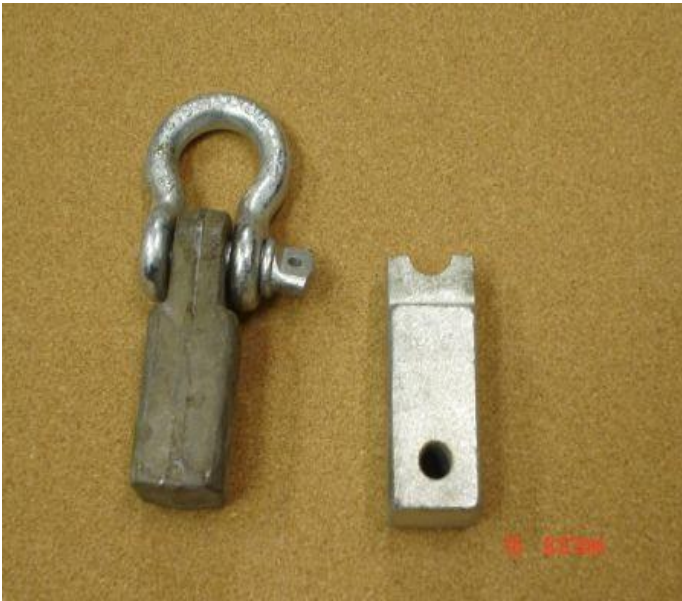
Contributing Factors: The pasture was snow covered and low spots were hard to see. The clevises used are **NOT** designed for this application. As stated by the manufacturer of one of the clevises, they are to be used for winching and hoisting only. They are not designed to withstand the forces involved in a vehicle recovery. One of the devices was counterfeit and made of weaker material.

Photograph shows both clevises used in the vehicle recovery (note the bend in the pin on the left)

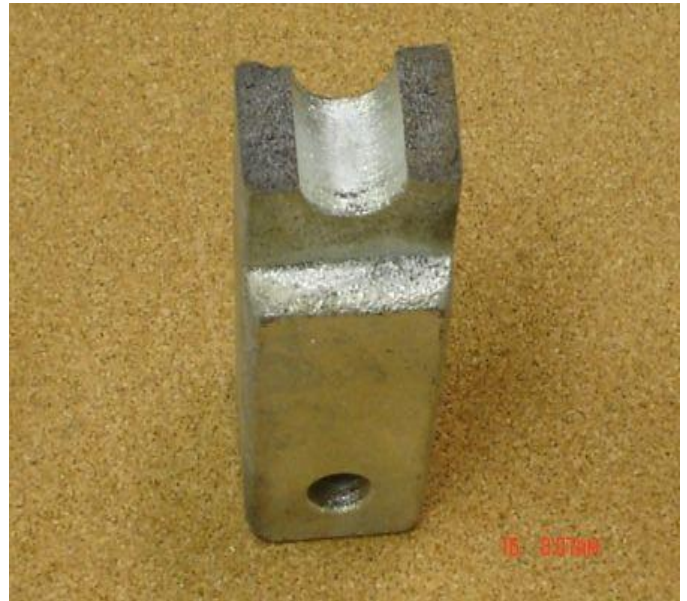
Description of incident: An employee was driving through a pasture to a valve site when his truck became stuck in a low spot of the snow bank. There was another truck present. The one truck was equipped with two clevises that fit into a trailer hitch receiver. Each one was made by a different manufacturer. With the two trucks back to back and a tow rope connecting the clevises, the employees began their recovery. They gave the rope a “slight jerk” and the clevis on the stuck vehicle broke, becoming a projectile and narrowly missing the recovery vehicle and its driver. The piece that broke off of the clevis was never found.

This photograph is a close up of where the clevis block failed
