Vehicle Recovery Fatality Report

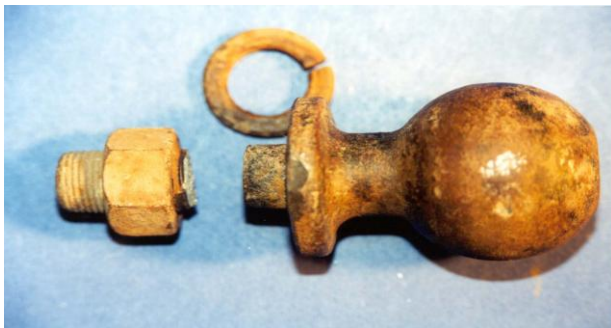
Photograph #1-

Contributing Factors: The hitch ball was not manufactured to be used for vehicle recovery and the load applied to it was extremely high as compared to its design capacity. The muddy ground was too soft for the forklift to safely operate. Also the workers were unaware of the hazards and limitations of the truck and attachments used to retrieve the stuck forklift. There was no hazard assessment done on site before the recovery attempt.

Shows the broken hitch ball. Upon further investigation, the ball was found to have no signs of damage prior to the incident. The markings on the top were stamped 2" 3500 Lbs V5 indicating its size and load rating.

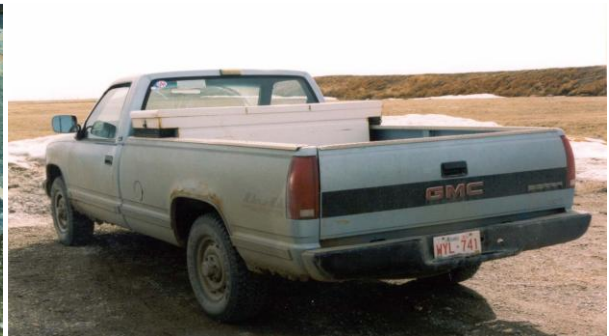
Photographs #2 and 3-

These photographs show the pickup truck used and a close up of the rear bumper where the hitch ball was attached.
