A summary of a NIOSH fire fighter fatality investigation

Volunteer Fire Fighter Dies After Being Struck by a Shackle on a Recoiling Tow Rope – South Dakota

Fatality Assessment and Control Evaluation
Investigation Report # F2006-22

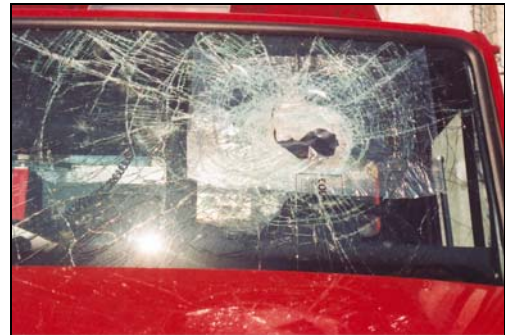
Windshield of the engine involved in incident

The second farmer began to move the tractor forward, putting tension on the tow rope. Within seconds, the small shackle on the draw bar broke, and the tow rope, with its shackle still attached, recoiled toward the engine. The victim, who had driven the engine into the field, was sitting in the driver's seat. Another fire fighter was sitting next to him in the passenger's seat. The shackle, still attached to the end of the tow rope, crashed through the windshield, struck the victim on the forehead, and exited through the back window.

An option for reducing the hazard of whipping cables or flying objects is to place a coat, blanket, tarp or similar object over the tow rope or cable before applying tension. In the event that the cable or

connecting hardware should break, the object on the cable will serve to weigh down the cable and reduce the possibility of the broken cable whipping or flying about.²⁻⁴ At least one manufacturer offers a commercial weight that is connected to the cable after all connections have been made and serves to hold down a broken cable to prevent the cable from whipping about.⁵ It is also good practice to raise the hood of the stuck vehicle to prevent the possibility of injury from flying objects. If at all possible, remove all passengers and the driver from the stuck vehicle before tightening the cable. Bystanders should stay as far away as possible and never downhill from vehicles being pulled uphill.^{2,4-5}

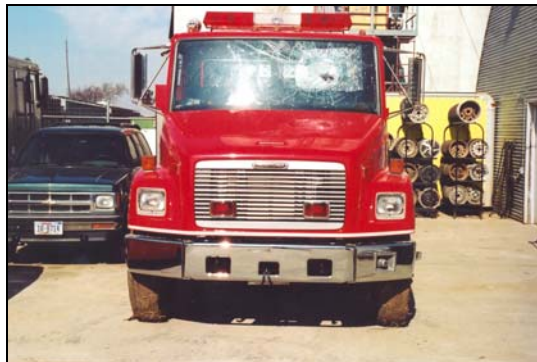
Photo 1. Engine involved in incident.
(Photo courtesy of County Sheriff's office.)

Engine #34, 1999 model, 35,000 lbs gross vehicle weight rating(GVWR), equipped with a 1,250 gallon tank (Photo 1).

On April 8, 2006, at approximately 1509 hours, the fire department was dispatched to a controlled grass fire that had overrun its boundaries and was threatening the neighbor's field. Several apparatus and personally owned vehicles responded and arrived on scene at about 1524 hours. The engine, which was the primary water source, was first on scene and had a full tank of water weighing about 10,375 lbs (1,250 gallon tank x 8.3 lbs/gallon = 10,375 lbs).

The engine was driven down into a soybean stubble field in proximity to the burning field and fire fighting activities commenced. After a short time, the fire was extinguished and fire fighters and apparatus started departing the scene. The engine, at that time with an approximate weight of 42,780 pounds (35,000 lbs GVWR of engine + about 7,780 lbs of water [3/4 tank of water]), was being driven out of the soybean field and became stuck in mud in a low, wet spot.

Recommendation #1: Fire departments should utilize a heavy towing service for apparatus and revise standard operating guidelines (SOGs) accordingly.

Discussion: Heavy towing services are offered generally throughout the country and should be utilized to tow lodged or disabled apparatus. Heavy towing is accomplished with the use of specialized equipment such as, but not limited to, wire rope, winches, chocks, chains, air bags, and heavy duty towing vehicles. Personnel who perform heavy duty towing are specially trained and utilize appropriate equipment needed for the job. In this case, a polyethylene tow rope with shackles attached to either end was attached on one end to a smaller shackle on the draw bar of a farm tractor and on the other end, to a tow hook on the engine. When tension was applied to the tow rope, the shackle on the farm tractor failed, allowing the shackle and tow rope to recoil through the engine's windshield and striking the victim on the forehead. Apparently, the capacity of the smaller shackle attached to the farm tractor was exceeded resulting in the incident occurring. The victim died of his injuries three days later. *(Note: Following the incident, the fire department added a procedure to their SOGs which identifies the use of a heavy towing service for any future heavy towing needs. This procedure includes the name and telephone number of a heavy towing service available in the area).*

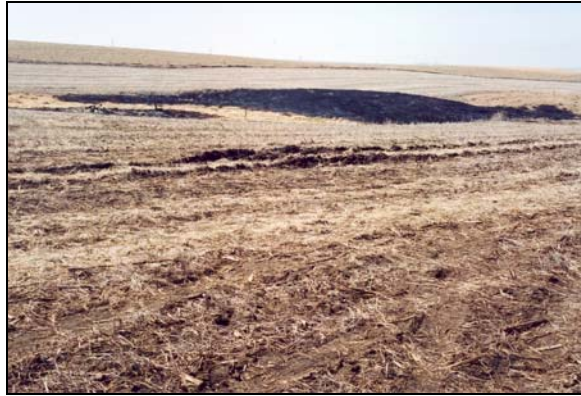
Photo 2. Incident site.
(Photo courtesy of County Sheriff's office.)

The incident site was a soybean stubble field with a slight incline. Wet spots existed in the low areas (Photo 2).

Discussion: Fighting wildland fire often requires that apparatus travel off the roadway to reach the fire. Weight, low ground clearance, and larger turning radius make some structural fire apparatus unsuited for off-road use. Even with apparatus specifically designed for off-road use, apparatus operators must know the capabilities and limitations of the apparatus they are operating and use them accordingly. Even on level terrain, an apparatus can become mired in soft ground, sand, or mud leaving it vulnerable to being overrun by a fire.⁶ In this case, the engine was not in danger of being overrun by fire because the fire had been contained, but the engine was driven into an area that was low and muddy and eventually became stuck in the mud. This situation resulted in the fire fighters trying to pull it out with the aid of a farmer's tractor which ultimately led to a fire fighter's death. Given the engine's weight of 42,780 pounds (35,000 pounds GVWR + about 7,780 pounds of water [3/4 tank of water]), slope of field and wet low spots, perhaps the engine could have been positioned on higher, flatter ground and may not have become stuck in the mud.

Recommendation # 4: Fire departments should ensure that apparatus used at an incident scene is positioned in a safe location.

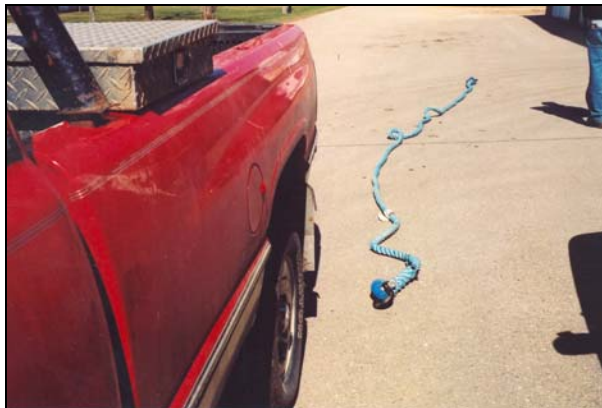
Photo 3. Polyethylene tow rope.
(Photo courtesy of County Sheriff's office.)

Polyethylene tow rope, 27 ½' long, 1 ½" diameter, rated to 37,500 lbs (Photo 3).

A farmer, who was watching the activities, saw that the engine had become stuck and offered to pull it out of the mud. The engine was emptied of water, and a fire department tow rope with shackles attached to either end was retrieved. *Note: The tow rope was rated to 37,500 lbs, but the shackles were only rated to 8 ½ tons (17,000 lbs) capacity each.*

Recommendation #2: Fire departments should develop and implement SOGs and safe work practices for the selection and proper use of tow ropes and shackles, and for other rigging fixtures to prevent loading beyond their structural capacity.

Discussion: Towing/pulling jobs are occasionally performed by fire departments using tow ropes, shackles, tow hooks and other rigging fixtures. Fire departments and fire fighters need to know equipment limitations and follow safety instructions supplied by the equipment manufacturer, such as the warning tag affixed to the tow rope and the working load limit stamped on the shackles. The warning tag on the tow rope used in this incident read – “When attaching the rope to a vehicle that is going to be pulled or to a vehicle that is to pull it, never attach the rope to a hook, clevis, chain, cable or other metal object that is weaker than the rated strength of this rope that is on the attachment.” In this case the engine had a gross vehicle weight rating of 35,000 lbs. The polyethylene tow rope used was rated to 37,500 lbs; however, the shackles (1” diameter) attached to the ends of the tow rope had a working load limit (WLL) of only 17,000 lbs each. Additionally, a smaller shackle attached to the

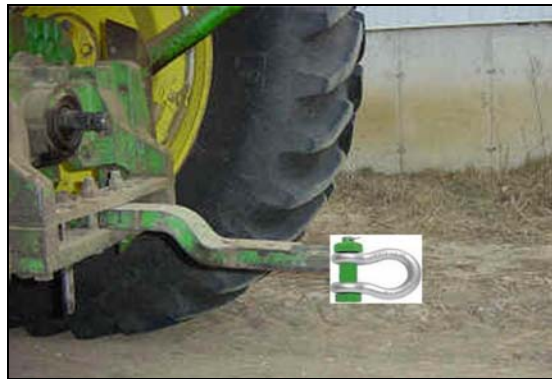
Photo 4. Shackle attached to draw bar on larger tractor (representation only).

Farm tractor with small shackle (about 1/2 the size of the shackle attached to tow rope - witness account) attached to draw bar of tractor (Photo 4). *Note: The broken shackle was lost prior to the investigators arrival, and the photo is a representation only.*

the draw bar of his tractor. The farmer made several attempts to move forward and pull the engine free, but was unsuccessful. At that time, a second farmer brought his larger tractor to the scene. The small shackle and connections were removed from the smaller tractor and connected to the drawbar of the larger tractor.

draw bar of the tractor used in this incident, according to witness statements, appeared to be about half the size of the shackles attached to the tow rope, and its rating is assumed to be less than the 17,000 lb rating of the larger shackles. Theoretically, the shackle (1/2" diameter) on the draw bar could have had an approximate WLL of only 4,000 lbs. Once tension was applied to the tow rope with shackles attached, the undersized shackle on the draw bar of the tractor broke, allowing the tow rope and its shackle to recoil through the windshield, striking the victim.

Cables, chains and other hardware will have similar corresponding safe work load ratings. In this incident, the broken shackle could not be located, but, witness statements disclosed that the shackle that failed appeared to be "half the size" of the shackles (1" diameter) on the ends of the tow rope. Using the common sizes and safe working load limits provided above, the small shackle (1/2" diameter) may have had a capacity of around 4,000 lbs. Since the stuck vehicle had a gross vehicle weight of 35,000 pounds, all hardware used in the rigging should have been rated for a safe working load above this weight.

When rigging an object for towing/pulling, only appropriate sized connecting hardware should be used. Screw-pin type shackles (farm clevises) should be stamped with their safe working load limit (in tons) somewhere on the body of the clevis. For example, some common sizes and safe working limits for drop forged steel screw pin shackles are:¹

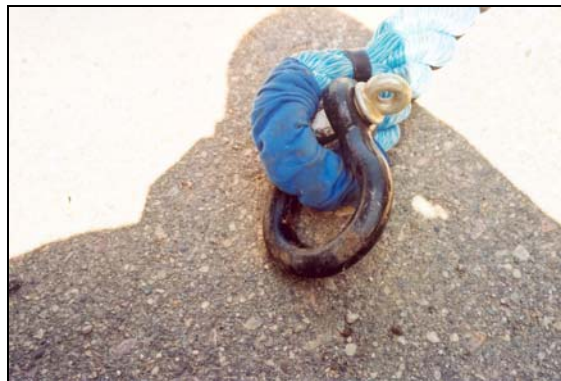
Photo 5. Screw pin shackle (also known as Farm Clevis). *(Photo courtesy of County Sheriff's office.)*

Shackles (also known as Screw Pin Shackle and Farm Clevis), attached to either end of the tow rope with a working load limit (WLL) of 17,000 lbs (8 ½ tons) each (Photo 5).

The shackle on one end of the rope was attached to a hook located on the front of the engine. The farmer attached the shackle on the other end of the tow rope to a smaller shackle already attached to

3/8"	2,000 lbs or 1 Ton	1 1/8"	18,500 lbs or 9.5 Tons
1/2"	4,000 lbs or 2 Tons	1 1/4"	24,000 lbs or 12 Tons
5/8"	6,500 lbs or 3.25 Tons	1 3/8"	27,000 lbs or 13.5 Tons
3/4"	9,500 lbs or 4.75 Tons	1 1/2"	34,000 lbs or 17 Tons
7/8"	13,000 lbs or 6.5 Tons	1 3/4"	50,000 lbs or 25 Tons
1"	17,000 lbs or 8.5 Tons	2"	70,000 lbs or 35 Tons
